The Galt Wreck

By R.L. Kennedy

The Galt wreck took place on the Canadian Pacific Railway in Galt, Ontario at 9.35 p.m. on May 2nd, 1956.

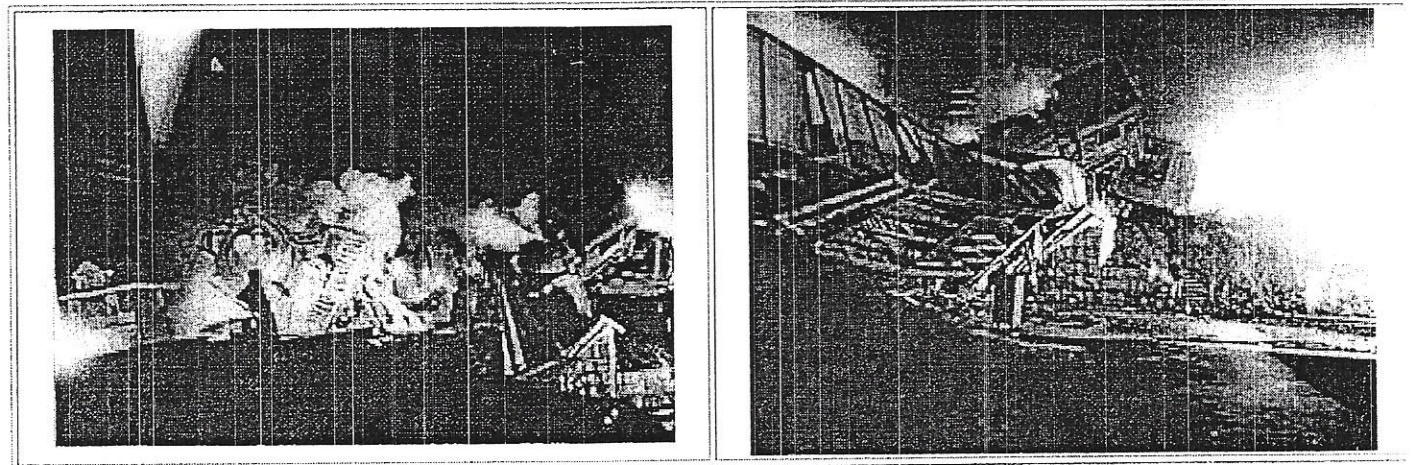
Scenes from the night of the wreck. *Tragedy in Galt* courtesy of Paul Langan.
