**CNR 6167**

Have Report At 335PM That Train No 1 Engine 6166 With 15 Cars Collided With No 702 Eng 6167 With 41-1-3284 Tons About 315PM On Bridge Just East Of Montmagny Station Mileage 77 Montmagny SD Both Damage To Engine And Bridge One Refer CN 10010 Demolished Loaded With Fish Baggage Car 8778 Derailed Across Track On Bridge Steam Cranes From Joffre And Riv Du Loup Ordered At 335PM All Local Officers Going To Scene Of Accident Further Details To Folow.D-217.

Anticipate Have Freight Cars Out Of Way At West End Early This After Noon, And To Have Engs 6166 And 6167 Rerailed And Clear Of Bridge Late Tonight. Tender Of 6166 Train No 1 Resting On South Side, Girder, And Now Being Rerailed By Riv Du Loup Auxiliary.Pony Truck And Drivers Both Engs Derailed But Close to Rail.Twenty Freight Cars Six With Mdse, And14 With OCS Coal, Derailed And Piled Up, Both Sides Of Track Between Bridge And Crossing Distance About Two Hundred Feet.Estimated Damage Eng 6166 Thirty Five Thousand Dollars, to 6167 Forty Thousand Dollars, To Freight Equipment About Thirty Thousand Dollars, Also One Baggage Car Totally Destroyed And Another Very Badly Damaged. Anticipate Will Take About Fifteen Hours Make B

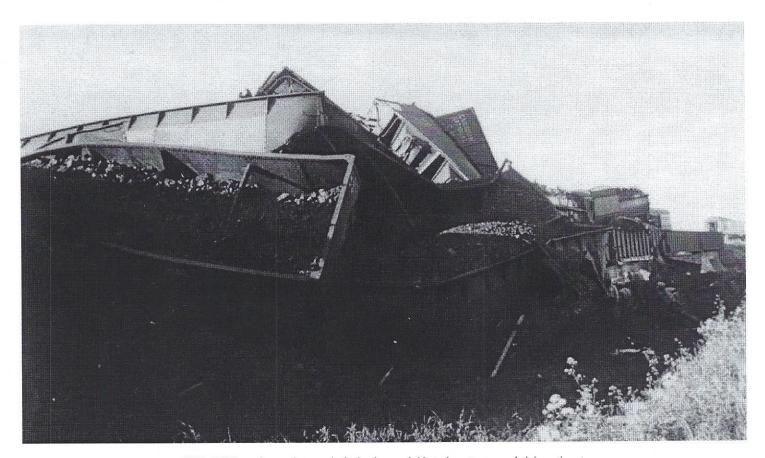
CNR 6166's tender can be seen in the background. Note the extreme angle it is resting at. John R. Davis photo, courtesy Grant Kingsland

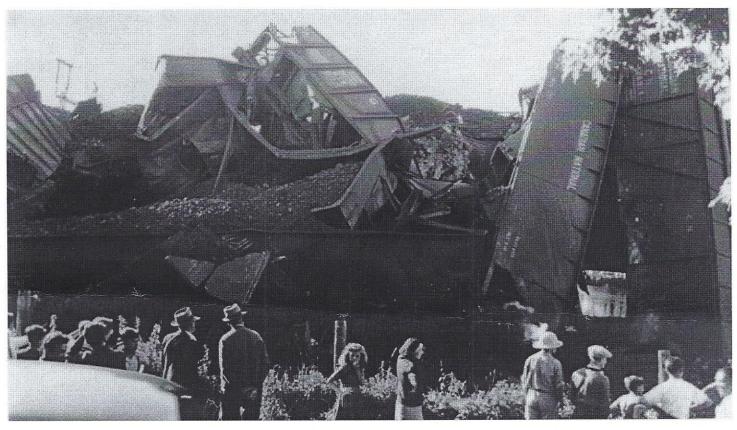
While 6166's train had almost stopped at the moment of impact, 6167's train was still moving at a high rate of speed, causing the damage seen here.
