The Galt Wreck

By R.L. Kennedy

The Galt wreck took place on the Canadian Pacific Railway in Galt, Ontario at 9.35 p.m. on May 2nd, 1956.

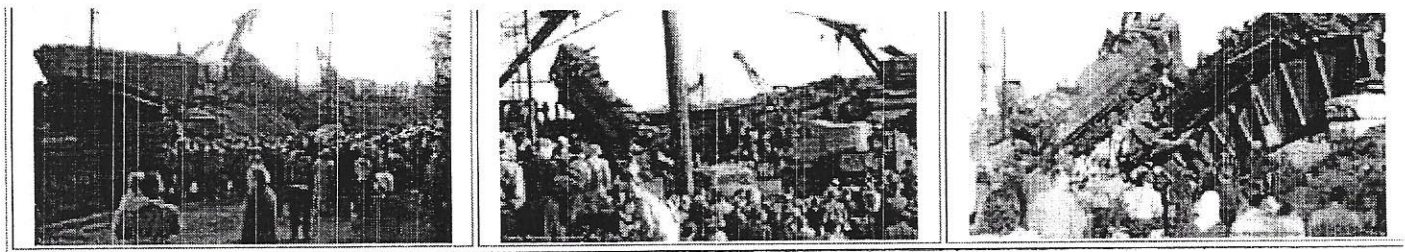
Scenes from the night of the wreck. *Tragedy in Galt* courtesy of Paul Langan.

2205 and 5420 struck the rear of the cut of 14 freight cars the Extra was pulling up the ladder track in front of the station. The collision was so violent it collapsed the bridge, causing both engines to fall down into the street

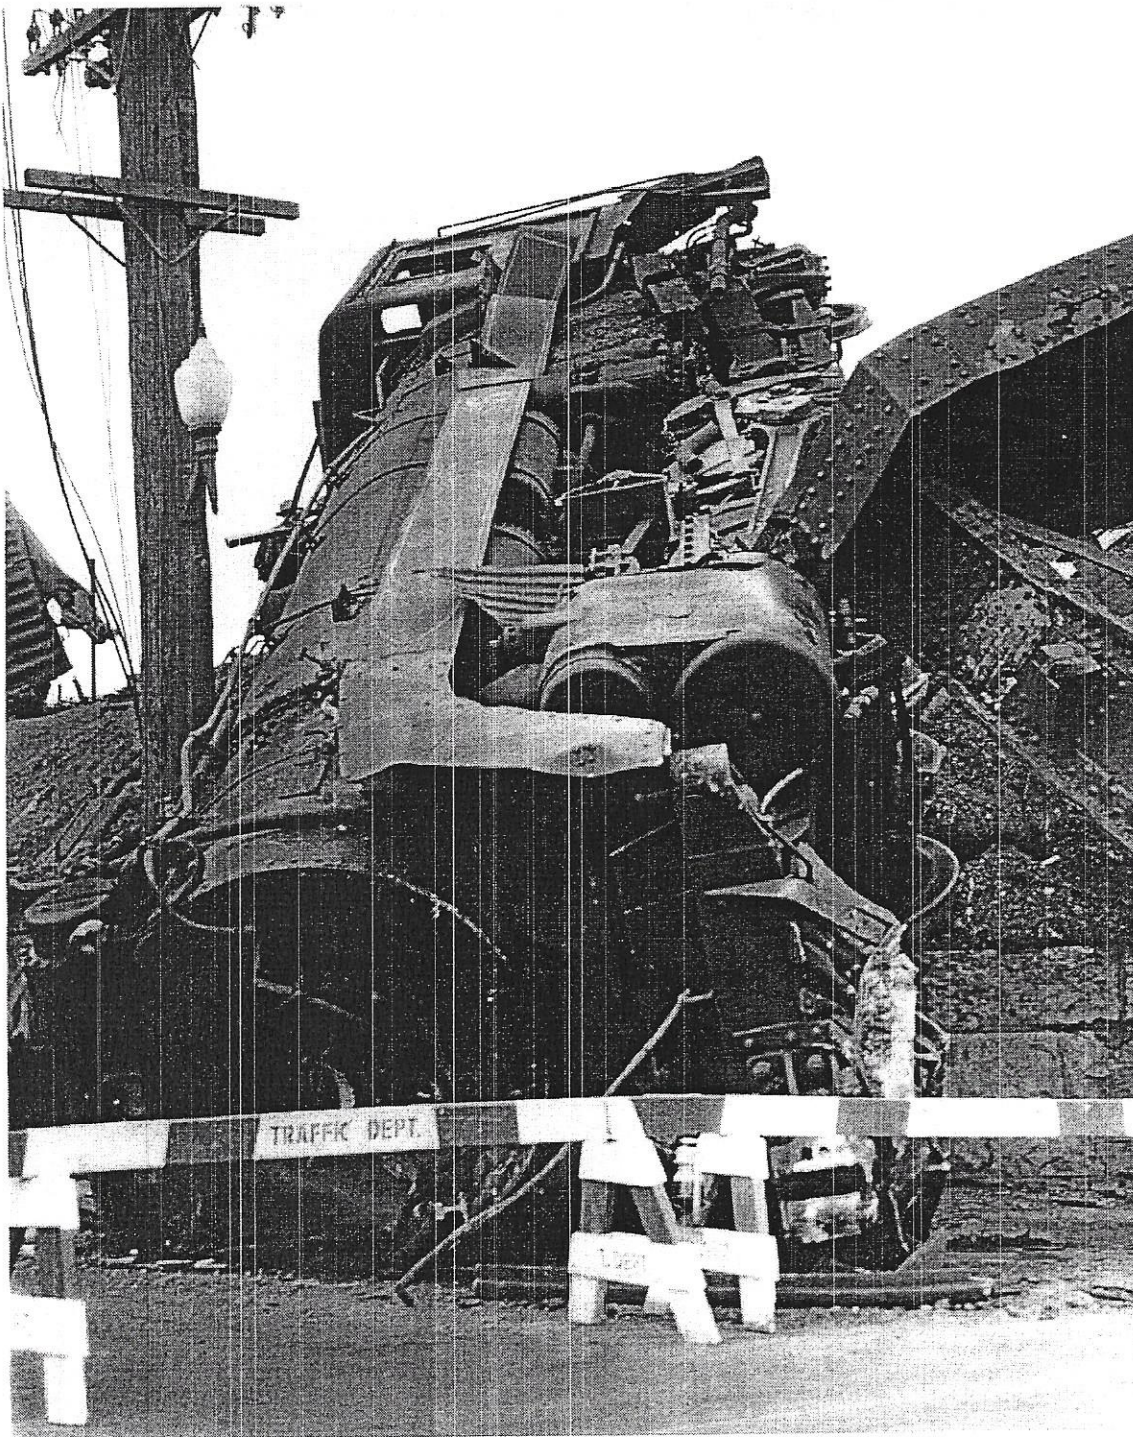
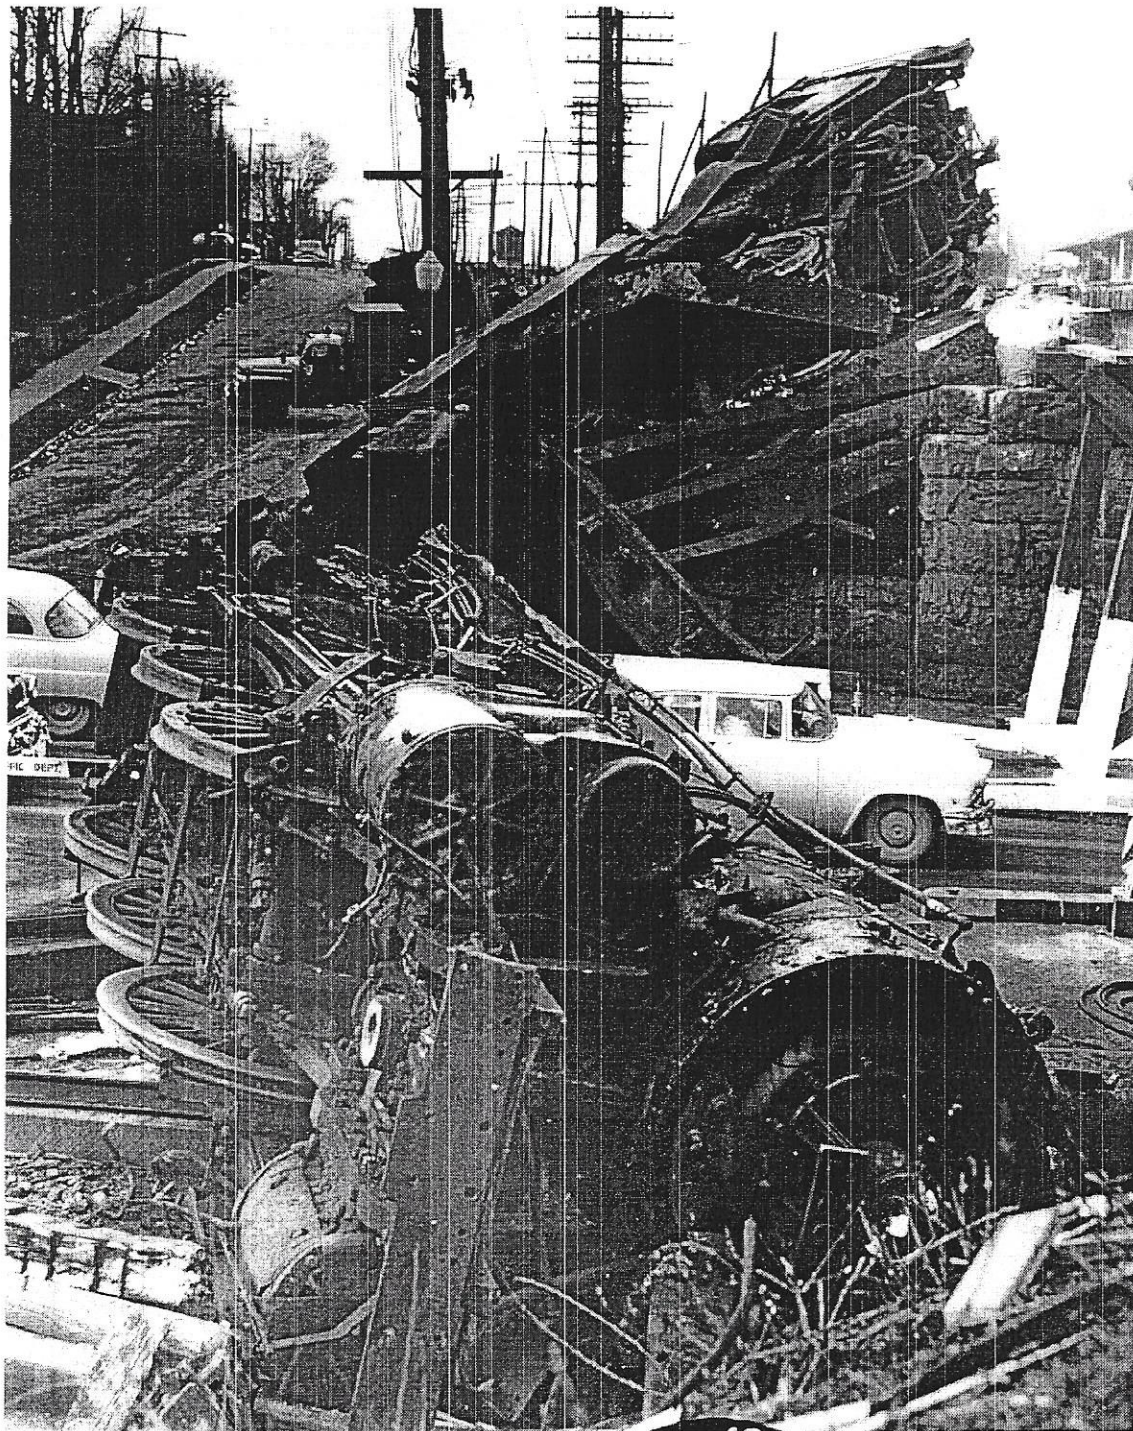
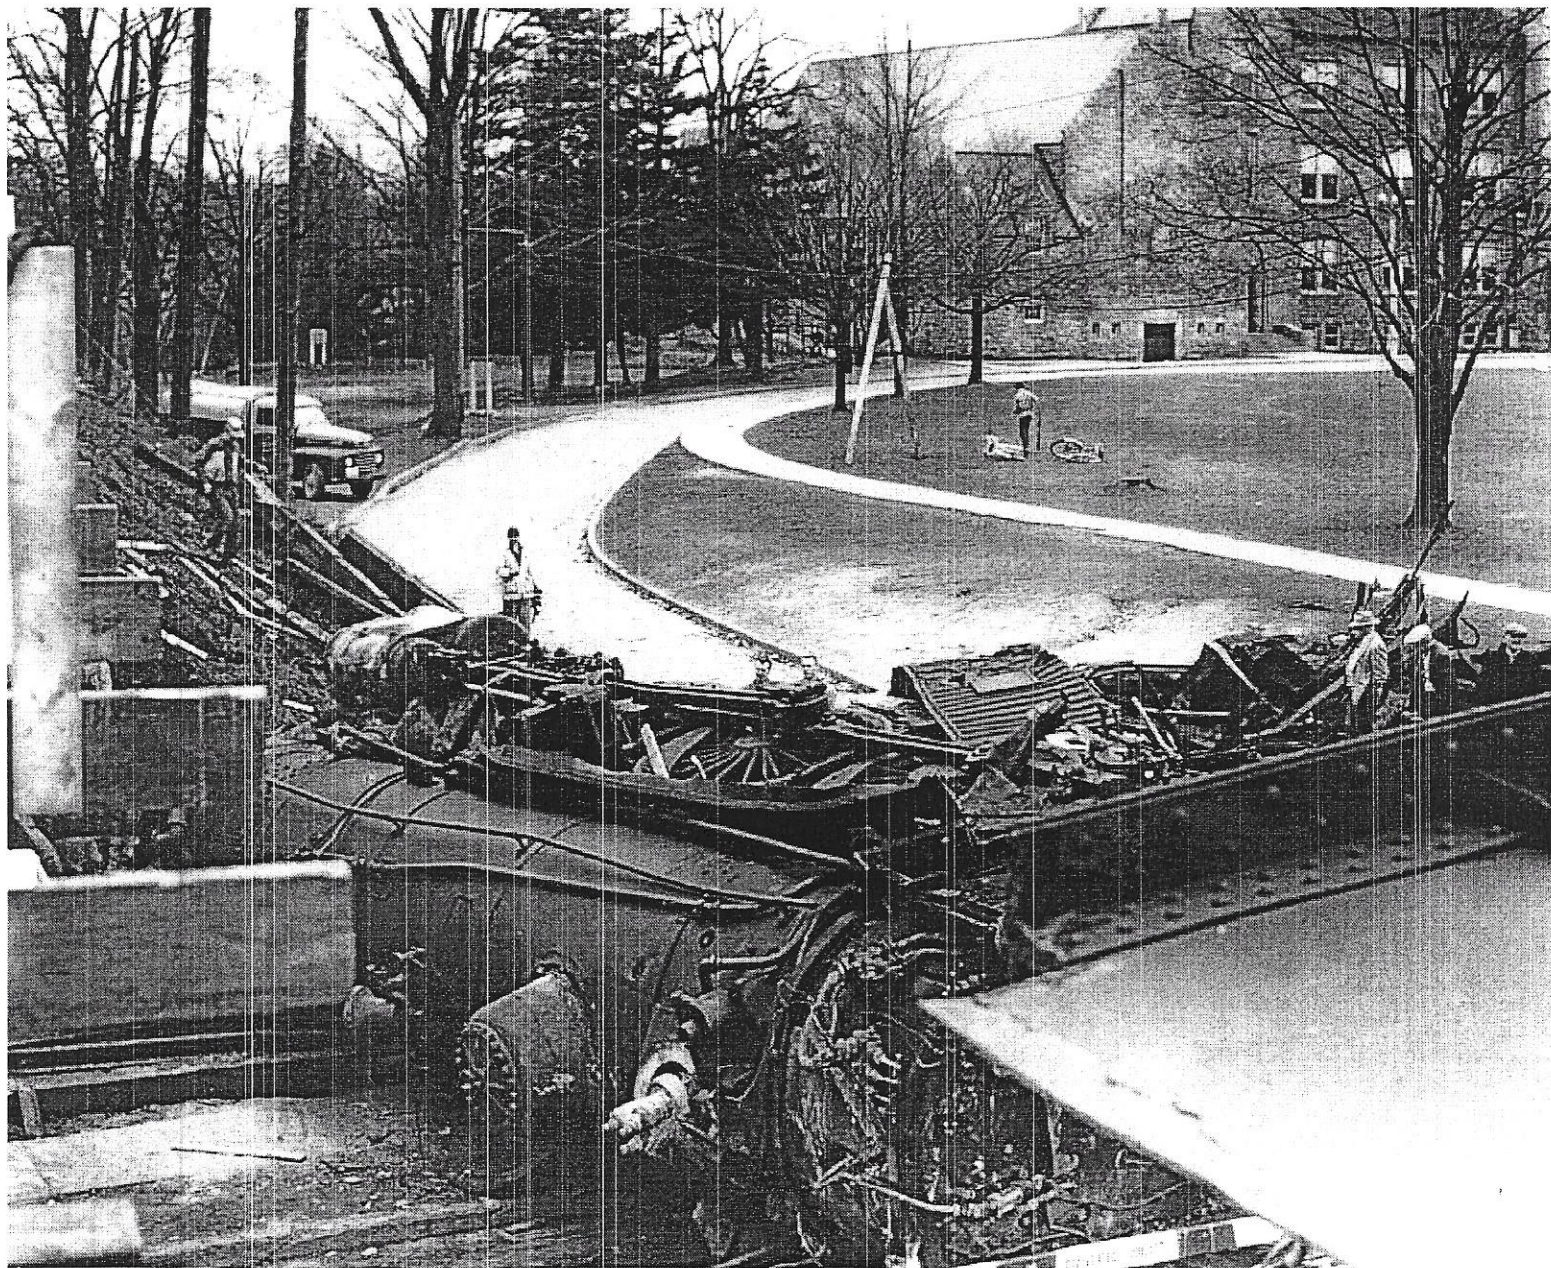
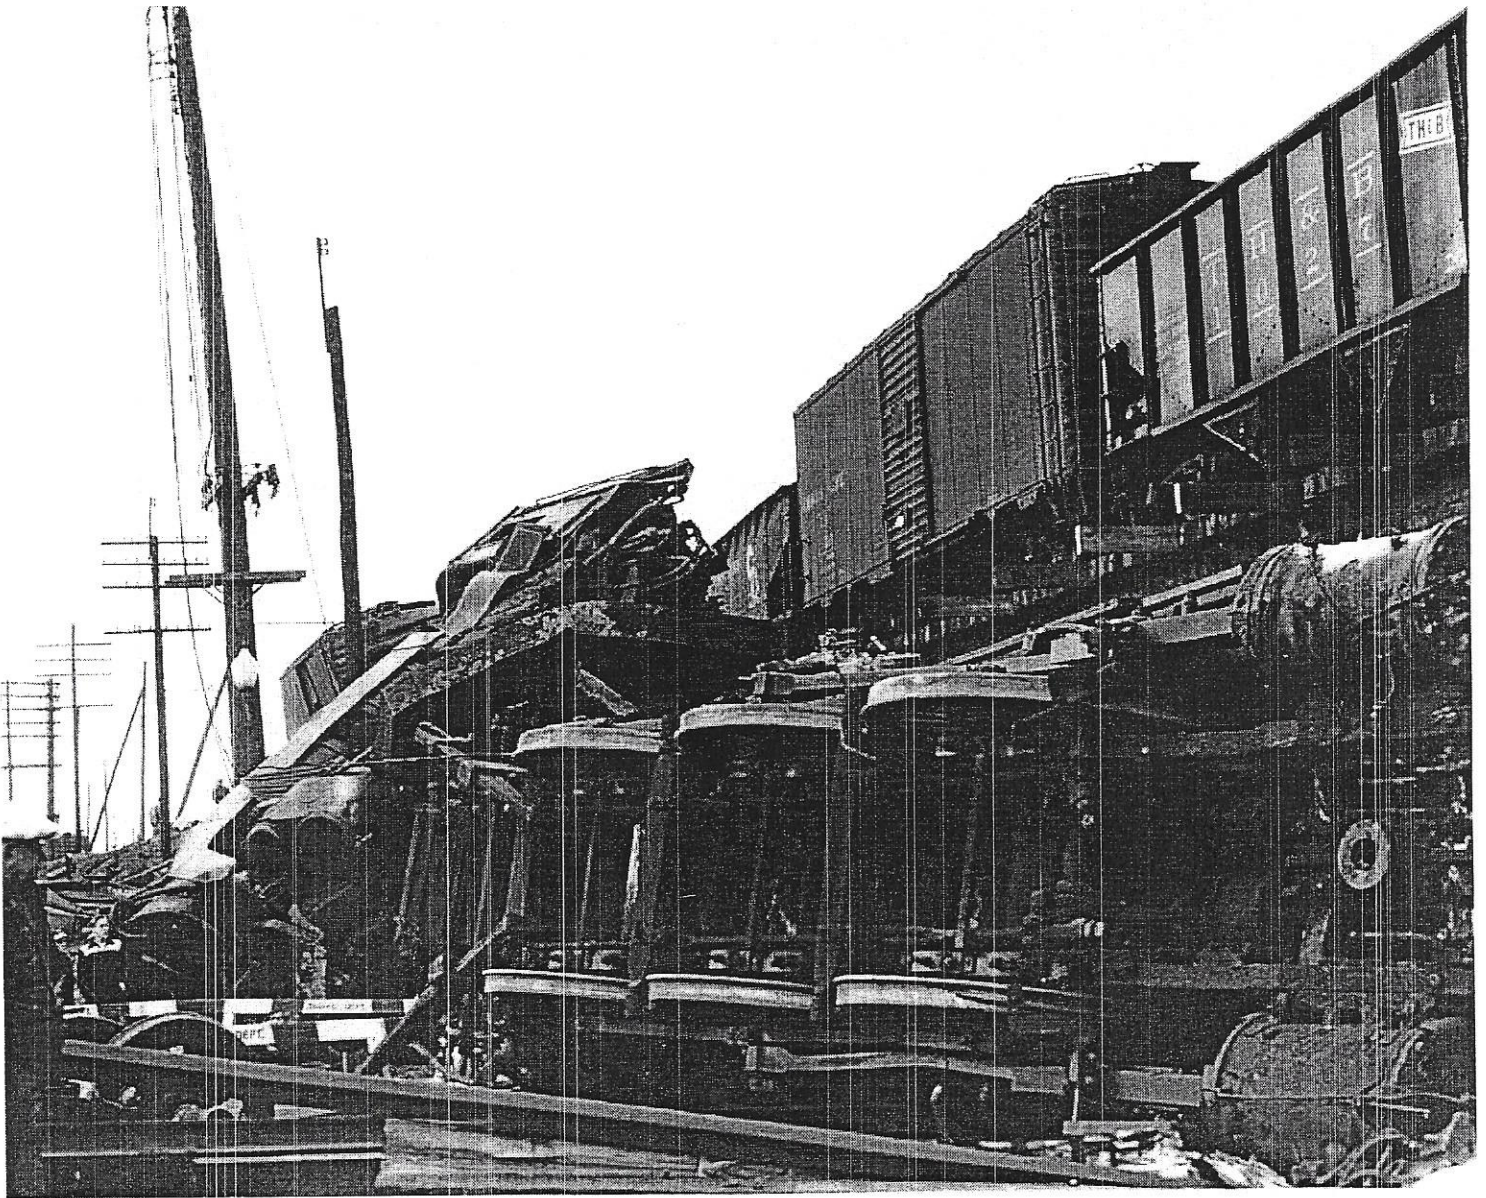
Engines 2205 and 5420 were both cut up for scrap, the wreck damage being so severe even though 5420 was relatively new engine being only 13 years old.
